2_22 PROCESSING END CONDITION PRIORITIES

Why are there guardrail warrants in some sections where the fill height is less than 5'?

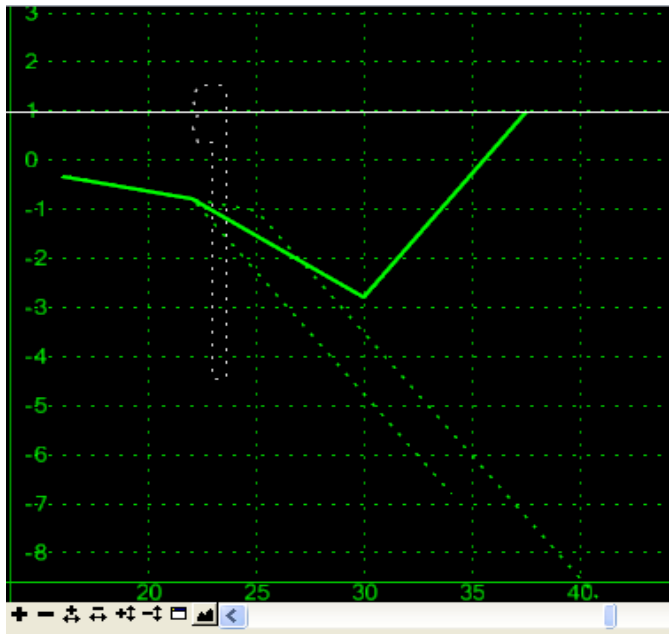
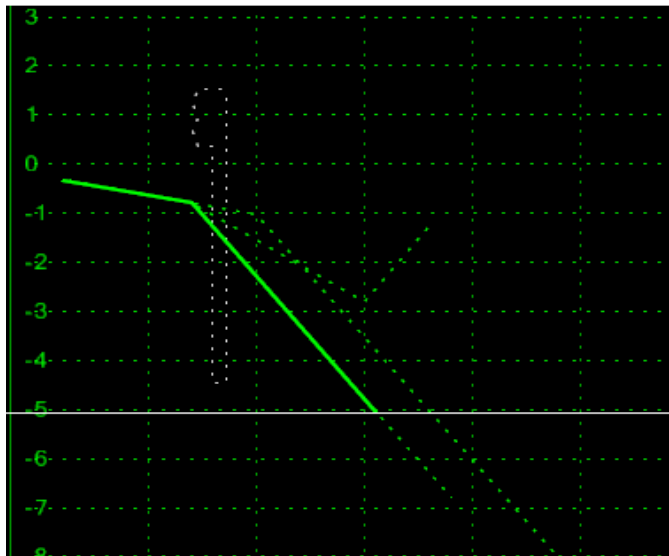
Mostly this is due to the existing terrain and each end condition branch has failed, except for the guardrail warrant. Depending on the side slope standard used, the normal cut and fill EC branch are tested first in priority assigned.

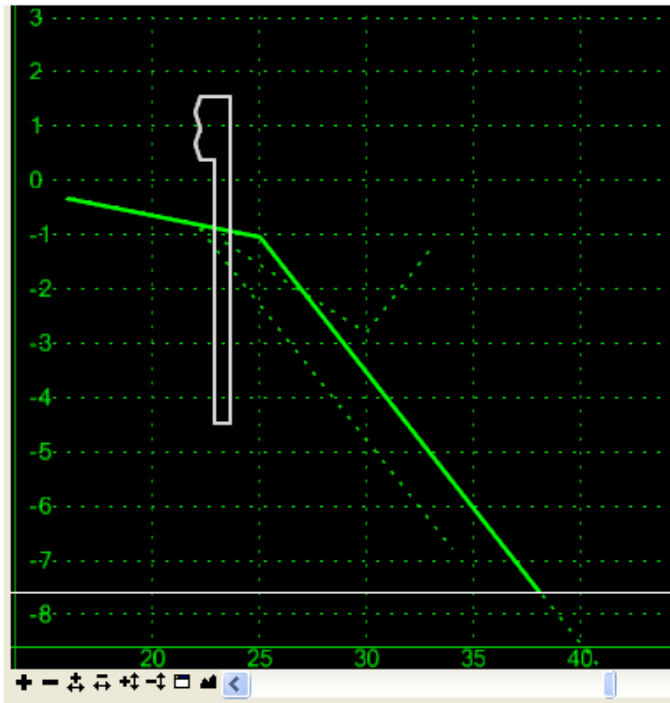
Guardrail warrant is processed last, either if the fill height is greater than 7' (with a slope of 2:1) OR if both cut and fill end condition branches have failed to solve for the existing ground.

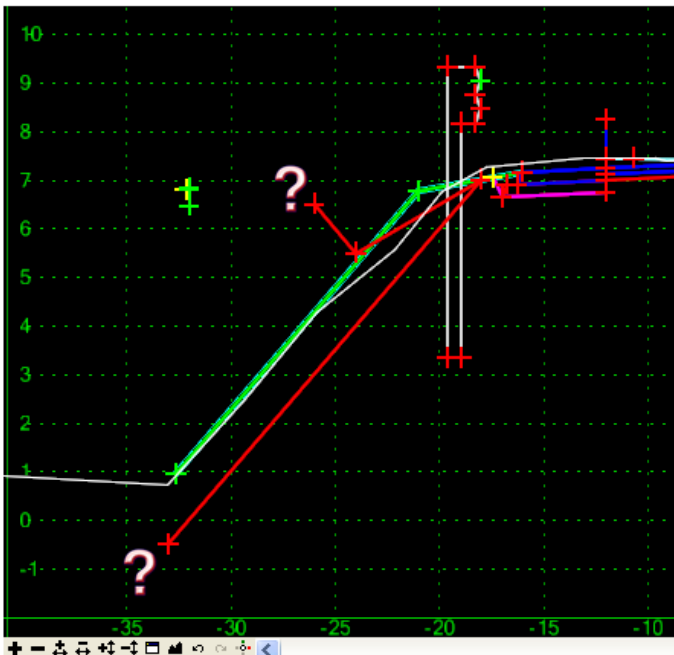
Applying the same principle to a real world terrain where the existing ground may not always be flat may reproduce an unexpected result.

In the above scenario, both the cut and fill end condition branches (indicated in red) have failed to solve for natural ground. The next logical end condition branch to test is the guardrail warrant (green). It is then successful and displayed even though the fill height does not warrant it (less than 7').

There are two ways to fix this issue, and both ways may have to be set as part of our standards.

1. One solution is to modify the ditch foreslope and place a point of interception with the existing ground. However, this will bypass the 1' minimum ditch rule in place.
2. Another option is to add another end condition following the ditch foreslope. Process this end condition branch after the normal cut and fill EC branches have failed to solve, and before the guardrail warrant EC branch gets tested.
